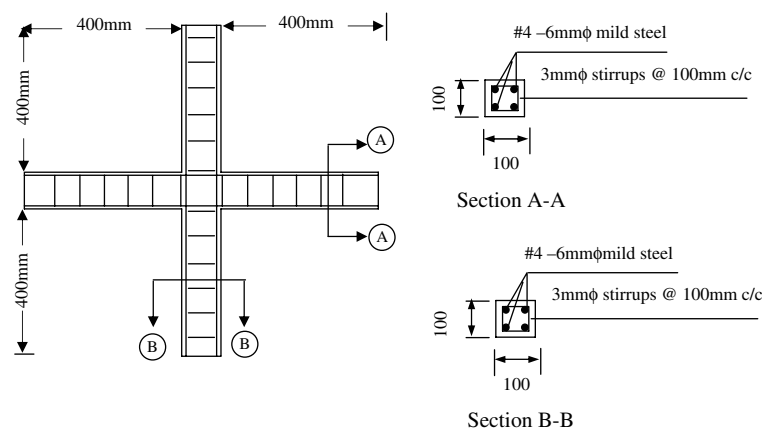
Fig. 1. Specimen with ductile joint reinforcement.

Two different types of RCC joints have been cast for experimental verification. One set of joints has adequate steel reinforcements with proper detailing of reinforcements at the critical sections (Fig. 1). In the other set of specimens the beam reinforcements have deficient bond lengths at the junctions with the columns (Fig. 2). When the beam of the joint is transversely loaded the first set is characterized by a long plastic zone (ductile) while the second set fails in reinforcement pull out and exhibits sudden failure (non-ductile).

The specimens in Figs. 1 and 2 were strengthened by using carbon and glass FRP materials. Prior to the application of the FRP the concrete substrate was smoothed by grinding and cleaning. The cement paste was removed from the surface and the coarse aggregates were exposed. Acetone was used to clean the surface. The corners of all the members were ground to create a minimum radius of 10 mm. Epoxy putty was used to fill the voids and concave areas. Figs. 3 and 4 present schematic arrangement for two typical systems; L-overlays and precured carbon plates respectively.

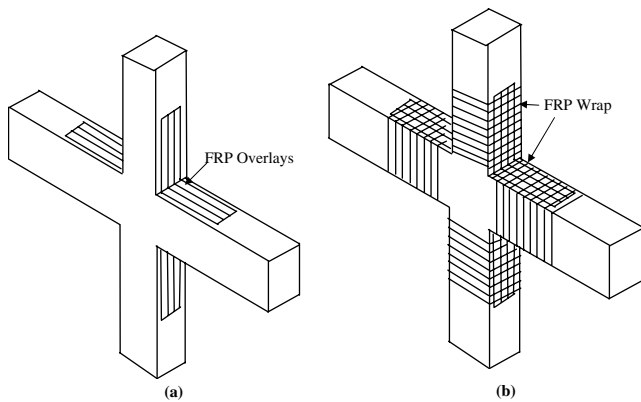
Fig. 3. Type A strengthening system—use of composite overlays.

layers. In step 1 FRP has been applied on the top and bottom surfaces concrete surfaces. The fibers were along the axes of the members (Fig. 3a). Subsequently, FRP wraps were provided over the inner layers (Fig. 3b). The direction of fibers in wraps was perpendicular to the axis of the members.

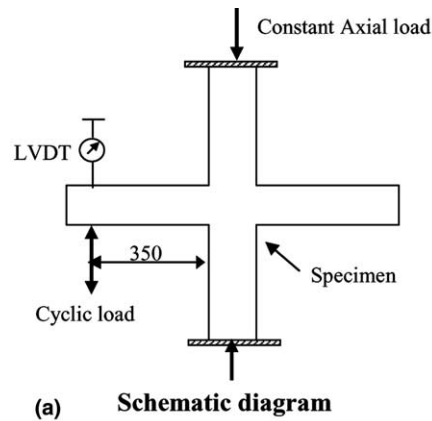
Fig. 7. Experimental setup.

The experimental setup is as shown in Fig. 7. The column was fixed at its ends on a loading frame. It was subjected to a constant axial load of 100 kN which is 50% of ultimate load carrying capacity of the column. This is considered the service load that the column is expected to carry under normal loading conditions.

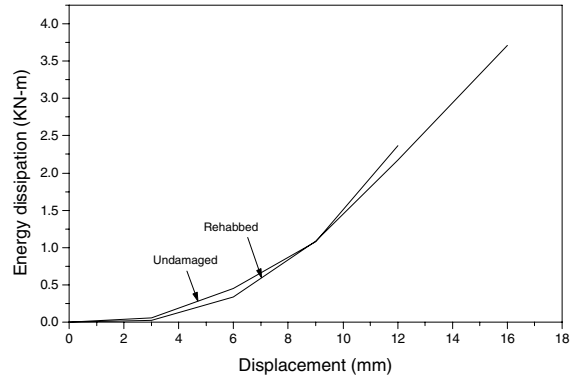
Fig. 17. Energy dissipation versus deflection plots for undamaged and rehabbed specimens.

structure after the rehabilitation (Fig. 17). The detailed results of rehabbed specimen are given in Tables 6 and 7.

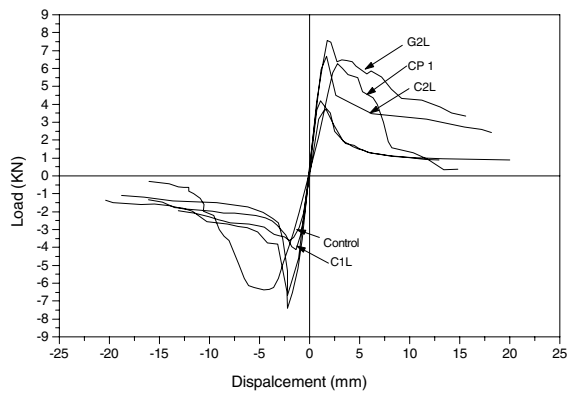
Fig. 19. Load versus deflection envelope plots for non-ductile specimens.

The load–displacement envelopes for the ductile specimens are plotted in Fig. 19. The envelopes let us com-

pare the relative performance of the specimens. All the FRP reinforced specimens had larger areas under the envelopes than the control specimen. The G2L-ND specimen had the largest envelope area followed by the C2L-ND, CP1-ND and C1L-ND specimens. The graph shows superiority of glass reinforcements over carbon reinforcement in case of non-ductile specimen.

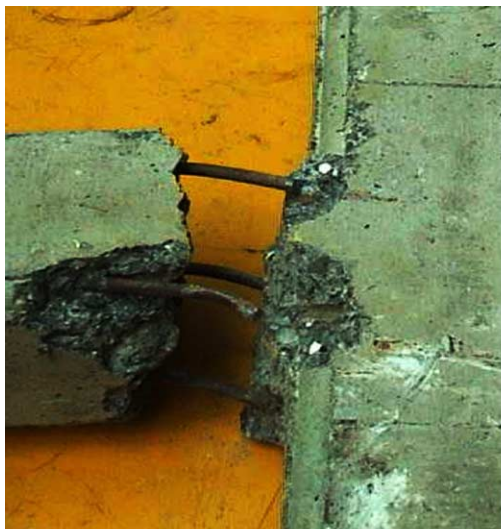
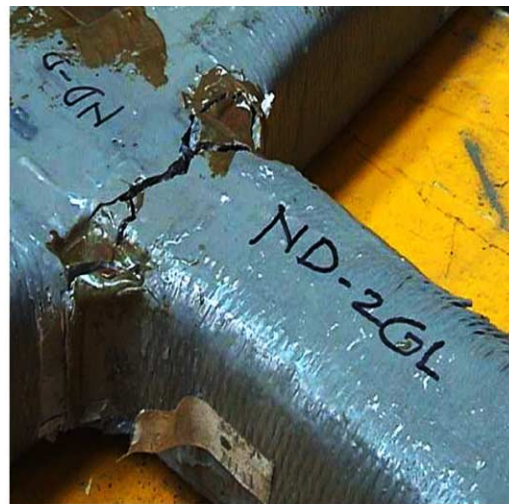
(a) Non-ductile control

(b) G2L-ND

(c) C1L-ND

(d) CP 1-ND specimen

Fig. 22. Failure patterns for non-ductile specimens.

The photographs of the failed specimens have been presented in Fig. 22. In Fig. 22a the failed control specimen is shown. It may be noted that the beam has failed

at the joint by pull out of steel reinforcement. Lack of development length prevented the formation of plastic hinge. The FRP reinforced specimens, on the other hand, did not have the reinforcement pull out. The failure planes were approximately vertical (Fig. 22b–d). The authors believe that the difference in the failure mode is due to the presence of the FRP overlays and wraps. They confined the concrete and did not allow it to spall. FRP Overlays helped to hold the beam in its position. As a result, the cracked concrete surfaces closed and they could react against each other at subsequent cycles. Therefore, the moment resistance of the beam was not lost. This offered higher collapse loads and displacement. To summarize, the main cause of superior performance of the FRP reinforced joints is the continuous confinement provided by the FRP wraps and overlays impeded the pull out of reinforcement through the inadequately detailed specimens.

Fig. 22d shows the failure of CP1-ND specimens. The failure pattern is similar to its counterpart ductile specimen discussed previously. The figure shows that both the CFRP plates and steel reinforcement have pulled out of the joint and there is no damage to the plate. A thin layer of cement paste is on the surface of the pulled out portion. This shows that the pullout was due to the failure of the cement paste in the groove. As a result, the ultimate failure of the joint was due to the pull out of both the steel bars and the CFRP plate.
